PSN # PSN004105u

Original publication date: 11-Dec-13; This is Issue #02, published date: 16-Dec-13. Severity/risk level High Urgency Immediately

Name of problem IP Office Unified Communications Module (UCM) goes into 'write protect' mode and Preferred Voice mail shuts down

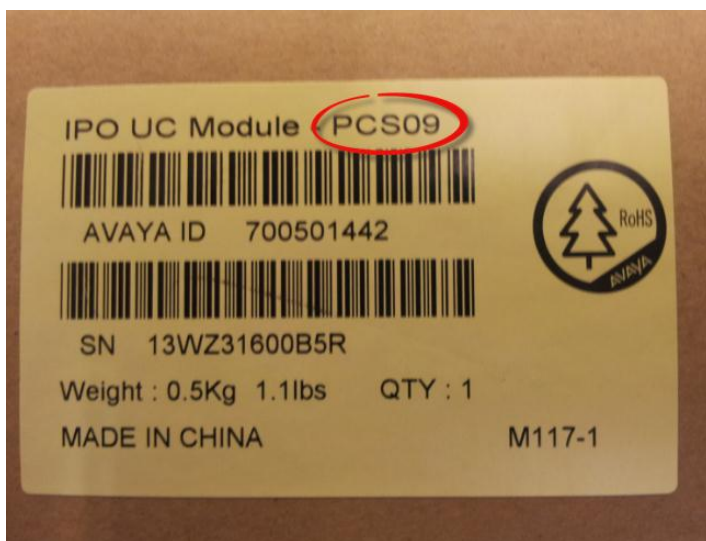
Figure 1.

In certain scenarios, the Solid State Drive (SSD) on the UCM goes into 'write protect' mode as early as a few weeks of use. Impacted UCMs can shut down the Preferred Edition Voicemail operation. The units exhibiting this issue would have a PCS level 9 for the UCM unit and PCS level 04 for the on-board SSD drive. The PCS level for the UCM unit can be located on either the UCM shipping box (see figure 1 below) or on the UCM module itself (see figure 2). The PCS for the on-board SSD drive is located on the top right of the blue sticker that is attached to the drive (see figure 3).

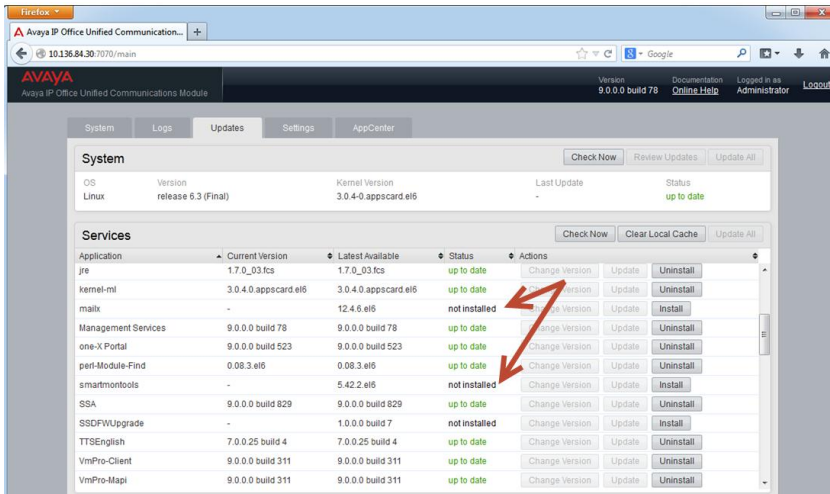
Figure 8

4. Upon successful completion of the SSD Firmware Upgrade package the UCM will automatically power down. For cases where the SSD Firmware Upgrade is not required the installation of the .rpm files will not effect the system and the UCM will not shut down.
5. The UCM can be restarted via the System Status Application (SSA) (see figure 14) or by pressing the top button on the UCM module.
6. **If the mailx.rpm and the smartmontools.rpm show that they are ‘Not Installed’ then you must perform the steps below to correct the corrupted .rpm files on the UCM (see Figure 8)**

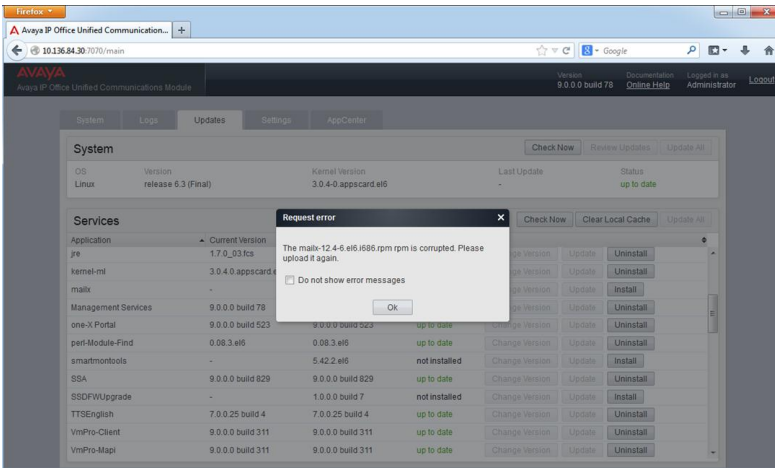
Figure 9

7. If you attempt to install the mailx and smartmontools from the ‘Updates’ page you will get a Request Error stating the .rpm file is corrupted. (See Figure 9)

If the mailx.rpm and smartmontools.rpm have been corrupted they can be reloaded to correct the issue. To reload the mailx and smartmontools .rpm files you will need:
