PSN # PSN004257u

Original publication date: August 7, 2014. This is Issue #01, published date: August 7, 2014

Name of problem UCM 7.03q SSD software load

700501442 UCM Module, PCS 12

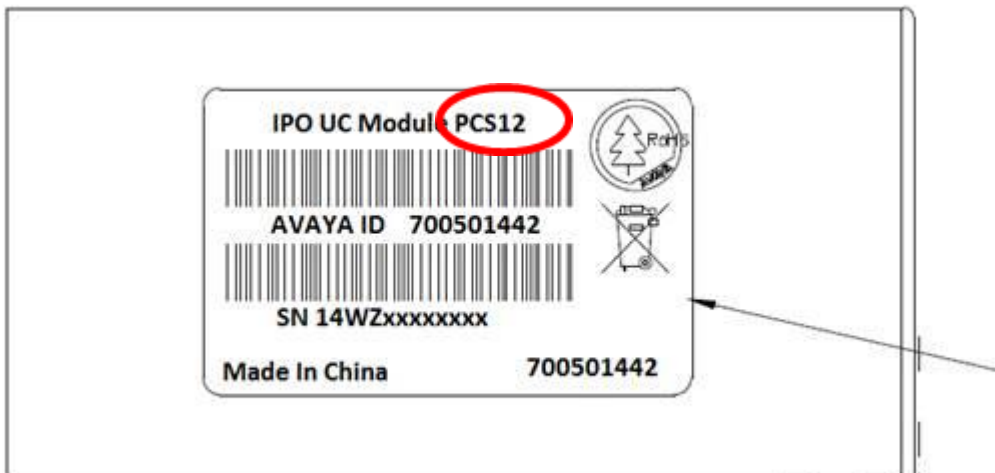
In a recent production of UCMs, the SSD drive vendor delivered version 7.03q software load that introduced a bug where the device may go into read only mode after a few weeks of usage or with a system reboot. With the SSD in read only mode, Voice Mail Pro and oneX portal applications could be unavailable or may be running with limited functionality. Unified Communications Module (UCM) units with PCS12 level software and within serial number ranges 14WZ2260080H6 through 14WZ25600GPY are affected.

Units are identified by the PCS12 level indicated on the external box of the unit. Serial numbers will fall into ranges between manufactured week 22 through 25 (22,23,24,25), which are the numbers highlighted in red: 14WZ226008H6 and 14WZ25600GPY

Apply the Critical Patch to update the SSD firmware to ver7.C3o. Units that are in staging or installed in a customer location and working would use the WebControl process either locally or through remote access. There is no need to return units with PCS12 or within the serial number range for replacement, simply apply the patch. Note: UCM PCS12s may be shipped to you from distribution and fall within the affected serial range. Applying the patch corrects the firmware issue.

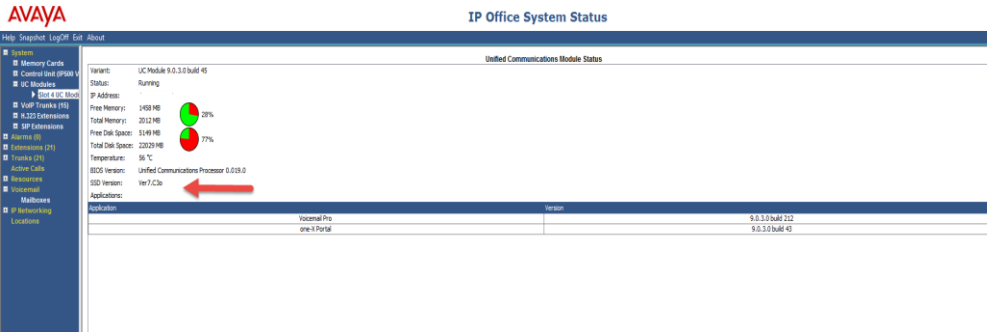
For units running 9.0 Service Pack 3 or higher the SSD Firmware level is shown in the System Status Application. Ver7.C3o is correct load. If the patch is applied to Ver7.03o, it will not change the firmware. Ver7.03o is acceptable.

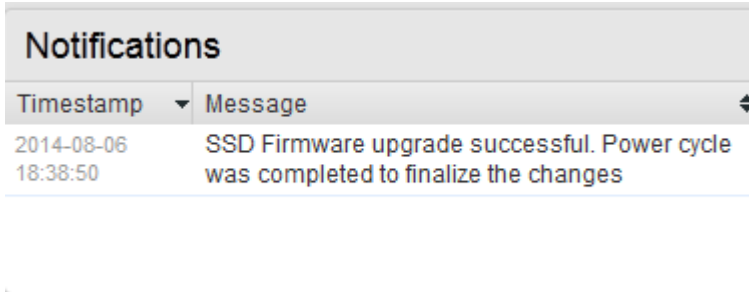
The WebControl Notification area also informs the status of the firmware upgrade.
