IP Office Technical Bulletin

Bulletin No: 226
Release Date: 20th August 2020
Region: Global

General Availability(GA)- IP Office Release 11.0.4 Service Pack 4

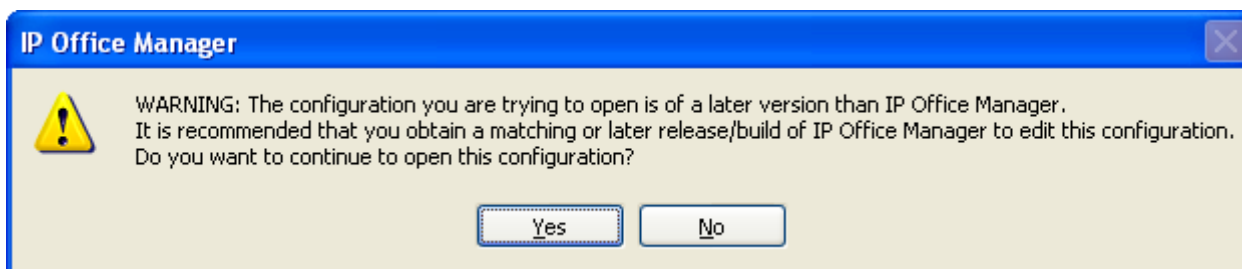
Previous GA releases of IP Office before 10.1.0.3.0.2 Manager are not compatible with systems running this release. Before upgrading an IP Office system to release 11.0, the Administration suite must also be upgraded. The following message will be displayed if attempting to access a system running the 11.0 release with an earlier version of Manager:

The IP Office Administration installer will detect previous installed versions and upgrade automatically. If a version earlier than 9.0 is installed, this must first be uninstalled before installing 11.0. It is not necessary to restart the PC after upgrading unless instructed to do so.
