## IP Office Technical Bulletin

**Bulletin No:** 232  
**Release Date:** 14<sup>th</sup> January 2022  
**Region:** Global

### **General Availability(GA)- IP Office Release 11.0.4 Service Pack 7**

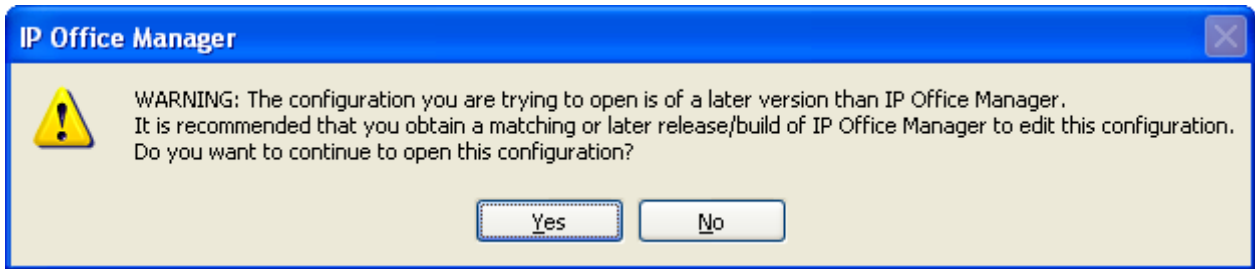
Previous GA releases of IP Office before 10.1.0.3.0.2 Manager are not compatible with systems running this release. Before upgrading an IP Office system to release 11.0, the

Administration suite must also be upgraded. The following message will be displayed if attempting to access a system running the 11.0 release with an earlier version of Manager:

The IP Office Administration installer will detect previous installed versions and upgrade automatically. If a version earlier than 9.0 is installed, this must first be uninstalled before installing 11.0. It is not necessary to restart the PC after upgrading unless instructed to do so.
