IP Office Technical Bulletin

Bulletin No: 237
Release Date: 23 June 2023
Region: Global

General Availability(GA)- IP Office Release 11.0.4 Service Pack 8

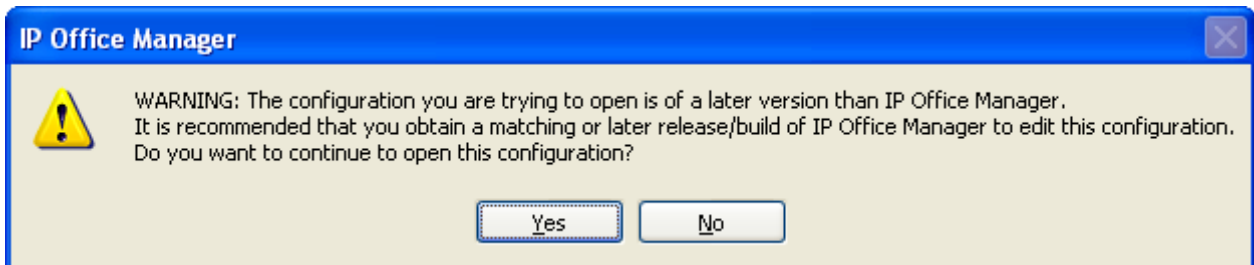
Previous GA releases of IP Office before 10.1.0.3.0.2 Manager are not compatible with systems running this release. Before upgrading an IP Office system to release 11.0, the Administration suite must also be upgraded. The following message will be displayed if attempting to access a system running the 11.0 release with an earlier version of Manager:

The IP Office Administration installer will detect previous installed versions and upgrade automatically. If a version earlier than 9.0 is installed, this must first be uninstalled before installing 11.0. It is not necessary to restart the PC after upgrading unless instructed to do so.
