IP Office Technical Tip

Technical Tip No: 025 IP Office Version 2.0 Upgrade
Installation Notes
Date: 26th November 2003

Upgrade Installation Notes for IP Office 403/406/412

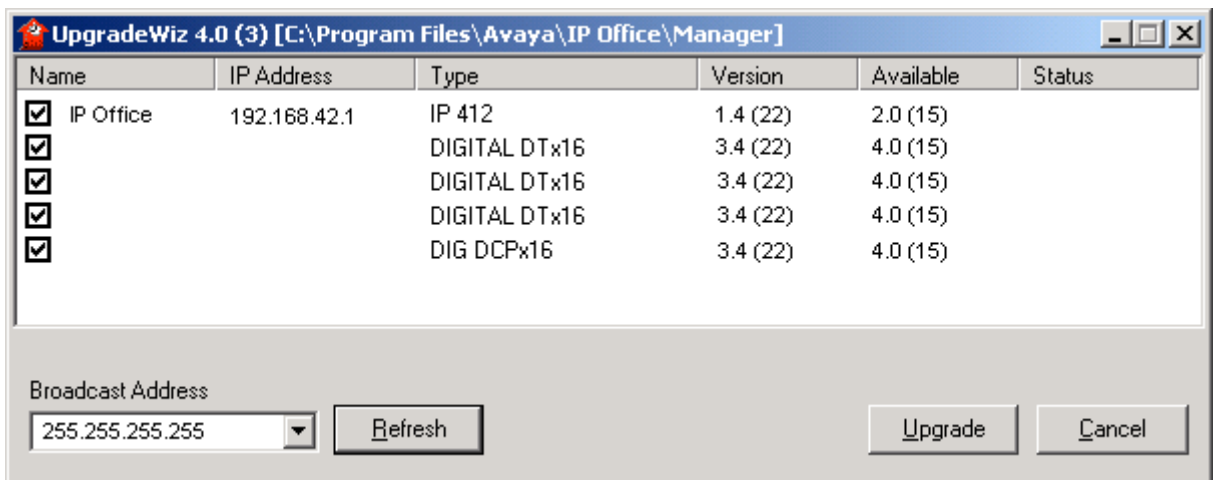
5. A window similar to the following is displayed. The list shows the current software levels of the units and the level of the appropriate bin file that is available in the Manager/Binary working directories.

6. The current Version and Available versions are displayed. Tick the check box under Name if it is not already ticked then click on Upgrade.
7. Enter the password of the existing configuration (not the default). Click OK and IP Office will reboot and undergo the upgrade cycle. This takes around a minute to complete. Click OK to finish once the upgrade has completed. This will close the UpgradeWiz window

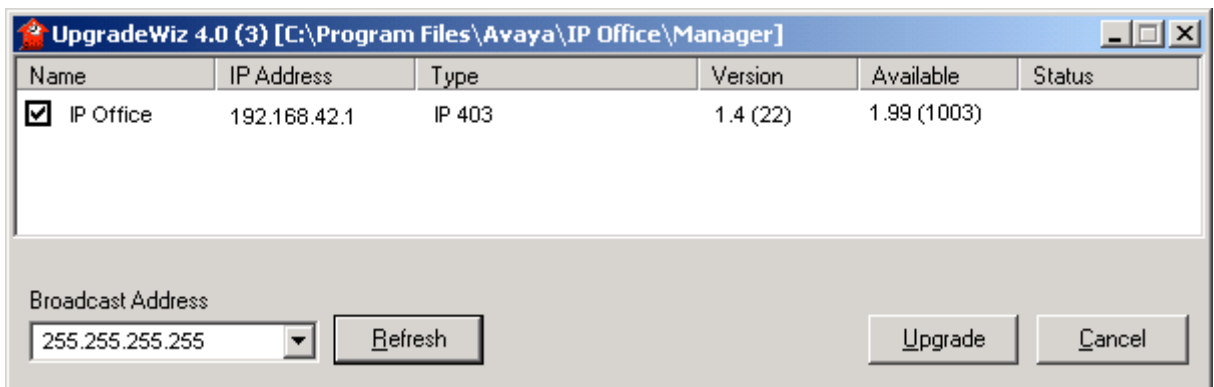
7. A window similar to the following is displayed. The list shows the current software levels of the units and the level of the appropriate bin file that is available in the Manager/Binary working directories.

8. The current Version and Available versions are displayed. Tick the check box under Name if it is not already ticked then click on Upgrade.
9. Enter the password of the existing configuration (not the default). Click OK and IP Office will reboot and undergo the upgrade cycle. This takes around a
