IP Office Technical Tip

Technical Tip No: 028 IP Office Version 2.0 Upgrade
Installation Notes
Date: 3rd February 2004

Upgrade Installation Notes for IP Office 403/406/412

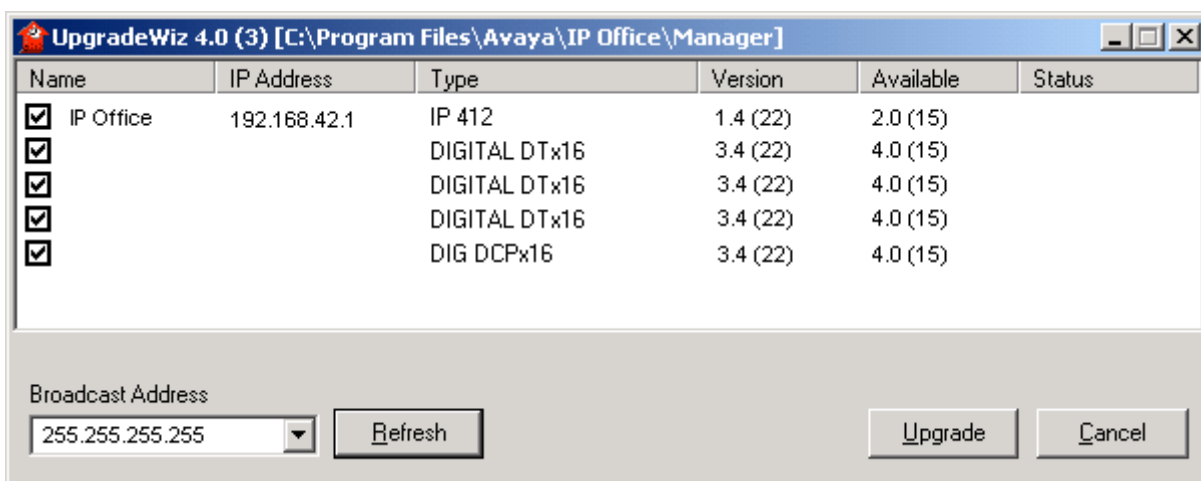
5. A window similar to the following is displayed. The list shows the current software levels of the units and the level of the appropriate bin file that is available in the Manager/Binary working directories.

6. The current Version and Available versions are displayed. Tick the check box under Name if it is not already ticked then click on Upgrade.
7. Enter the password of the existing configuration (not the default). Click OK and IP Office will reboot and undergo the upgrade cycle. This takes around a minute to complete. Click OK to finish once the upgrade has completed. This will close the UpgradeWiz window
